Re: PCB Remediation Status Update – Behlen Laboratory Roof  
University of Nebraska - Lincoln, Nebraska

This status update has been prepared to document the current status of polychlorinated biphenyl (PCB) remediation activities associated with parapet wall flashing joints on the roof of the Behlen Laboratory building. Specifically, this update provides the results of characterization sampling of the various media associated with the parapet wall flashing joints and the remediation and disposal plans based on those results. This letter does not provide a status update regarding the PCB remediation activities associated with the Behlen façade renovation as described in the December 2014 PCB Remediation Plan and the February 2015 Risk-Based Cleanup Request Approval (which are on-going as planned).

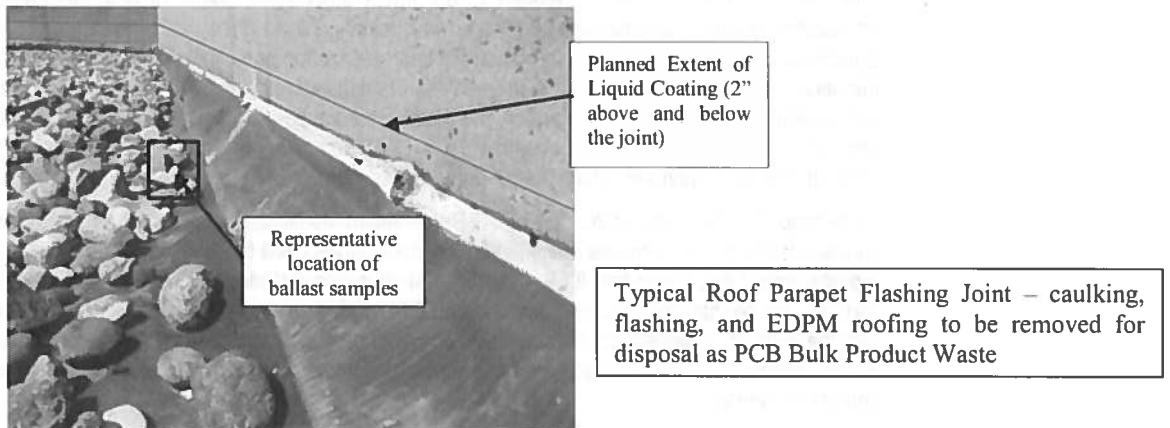
As described in the October 26, 2015 PCB Remediation Modification request (the Plan Modification), caulking containing PCBs > 50 ppm was identified on the inner parapet wall flashing joints along the perimeter of the roof (approximately 465 linear feet [l.f.]). The Plan Modification included the removal and off-site disposal of the caulking, copper flashing, and portions of the EDPM roofing as a single PCB Bulk Product Waste stream along with the in-place management of residual PCBs within parapet wall materials scheduled to remain in place (the EDPM roofing was to be segregated through characterization sampling as either PCB waste or general demolition debris).

*Roofing Ballast Materials* – Three samples of roofing ballast materials were collected and submitted for PCB analysis. The samples were collected from ballast materials at the base of the flashing to evaluate potential worse-case conditions with regard to PCB impacts. At each location, ballast material was collected and submitted to the analytical laboratory for processing and analysis. Upon receipt, the laboratory pulverized the ballast materials to generate a powder suitable for extraction via USEPA method 3540C and PCB analysis via USEPA method 8082. Analytical results from the three samples indicated that PCBs were non-detect with reporting limits of < 0.099 ppm, < 0.10 ppm, and < 0.10 ppm.

*EDPM Roofing* – In support of the waste segregation plan, two samples of EDPM roofing were collected from each side of the building at a distance of 12 inches from the flashing and submitted for PCB analysis (8 samples). Analytical results indicated that PCBs were present at concentrations > 1 ppm in 7 of the 8 samples with total PCBs ranging from 2.3 ppm to 28.8 ppm with an average concentration of 7.9 ppm. Results from one sample collected from the east side of the building indicated that PCBs were non-detect (< 0.79 ppm).

A photo of the typical roof conditions is provided below.

Based on these results, concerns over additional sampling damaging the watertight condition of the roof (prior to the scheduled replacement), and the amount of EDPM roofing material on the roof as a whole, the project team has elected to dispose of the entire EDPM roofing material as a PCB Bulk Product Waste with the parapet caulking and flashing materials.

*Parapet Walls* – Consistent with the remediation plan for concrete materials scheduled to remain in place on the façade of the building, residual PCBs in the concrete parapet walls at concentrations  $\geq 25$  ppm will be managed in place through the application of liquid coatings and secondary physical barriers. To determine the required extent of encapsulation, samples were collected from parapet wall materials at a distance of 2 inches above the caulked joints. As per the Plan Modification, two samples were collected from each elevation for a total of eight samples. Analytical results indicated that PCBs were non-detect in all eight samples (reporting limits of  $< 0.10$  or less). Based on these results, following removal of the caulking and flashing, two coats of liquid coating will be applied to parapet wall materials to a distance of 2 inches above and below the former joint (following the collection of baseline samples from former direct contact materials as described in the Plan Modification). In accordance with project requirements and the Plan Modification, the replacement roofing and flashing will be installed as a secondary physical barrier over the encapsulated parapet wall surfaces.
